Status of Riverbank Erosion and Proposal of Bioengineering Solution to Prevent Riverbank Erosion in Saline Soils Area. Case Study in Lung Tram River, Tan Hung Tay Commune, Phu Tan District, Ca Mau Province, Viet Nam

Abstract: The riparian of the Southwest area of Hau River in the Cuu Long River Delta, Viet Nam has great socioeconomic value. In there, the vegetation of mangrove soil in the Lung Tram River area, Tan Hung Tay commune, Phu Tan district, Ca Mau province has been promoting economic value and defensive value to protect river dikes, contributing to the increase biodiversity and stabilize the living standard. The article aims to present results of analysis and assessment of the socioeconomic conditions affecting the riverbank erosion in the study area. Based on the implement of methods: Secondary research collection methods; Topography, hydrology, water and soil environment survey; Sample plots investigation to evaluate plant species distribution, composition and biodiversity indicators. The results of the article have been showed that the topographic characteristics of the study area: the altitude ranging from 0.5-1.5m above sea level and is an area frequently affected by

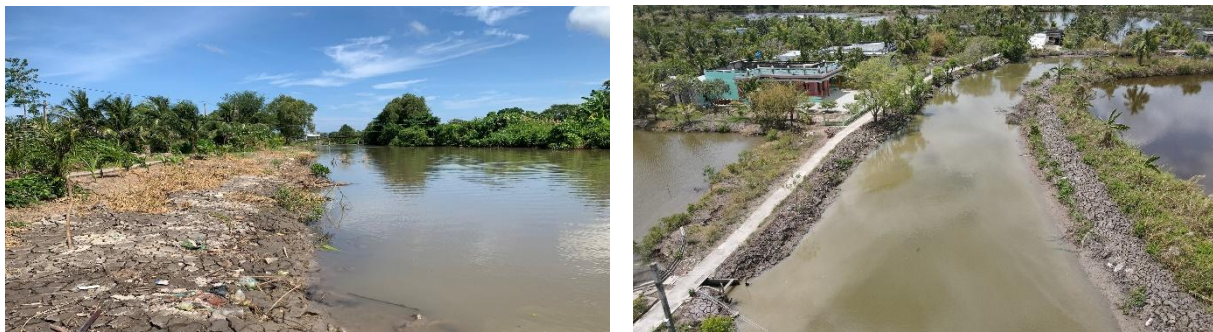
Figure2+3. Status of model construction location

1-1.2m create conditions for corrosion and erosion, especially during high tides and heavy rains. and in the high-water season. The terrain tilts in the Northwest - Southeast direction and the network of canals is intertwined with an almost perpendicular flow direction. At that time, the water force at the river confluence will create very strong underground vortices. When these underground vortices move, they will create "frogs jaw" at the river's junction, intersection and penetrate deeply into both banks until the riverbank collapses. In addition, with low-lying terrain, rising tides cause the riverbank soil to become saturated with water, increasing the weight of the bank soil mass, generating seepage pressure. When the tide recedes, the river water level drops, causing the weight of the soil mass and the pressure of water seeping from the bank into the river to increase. The rise of seepage pressure and increased water pressure from the bank to the river increases the factors causing bank slope slippage.
